ACE PRO 810 / RCD PLATINUM RECEIVER PROBLEM

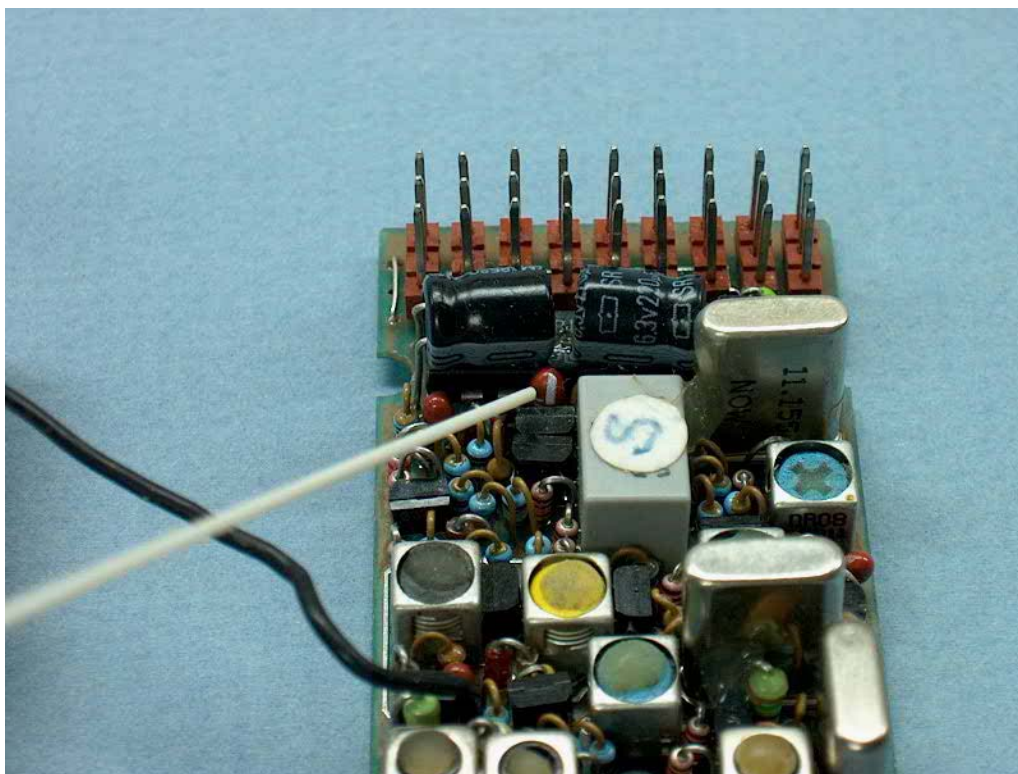
The photo above illustrates the problematic capacitor location in the subject receivers. The white pointer identifies a (replaced) 0.1 uf tantalum capacitor that was previously installed backward (reversed polarity) in my three Pro 810 receivers and my one RCD Platinum receiver. I do not know if every receiver out there has this same problem. This capacitor is part of the circuit frame detect timing operation and is shown here correctly installed.

The original “misinstallation” eventually (long time) apparently caused this capacitor to fail in an intermittent fashion and this in turn lead to intermittent malfunction of the receiver decoder. I was actually able to view the flawed circuit timing operation with a ‘scope on two of my receivers and found the capacitor to be improperly installed on all four even though two were still working OK.

The capacitor is nested very tightly and must be carefully unsoldered (solder wick recommended) and removed. DO NOT reuse the same capacitor but instead replace it with a new part. Install the replacement capacitor with the positive (+) lead dressed to the right as seen in this picture. I used Digi-Key (800 344 4539) catalog number P2053-ND. The somewhat larger Mouser (800 346 6873) catalog number 80-T350A104K035AS will also work electrically but is a tighter fit. The latter will be a lower cost purchase. DO NOT substitute a different value part, and do not undertake this if you don’t have the proper soldering skills and tools.
